**KENNETT FIRE & EMS REGIONAL  
COMMISSION**

**FIRE APPARATUS FLEET REVIEW AND  
ASSESSMENT**

**KENNETT FIRE COMPANY  
LONGWOOD FIRE COMPANY  
PO-MAR-LIN FIRE COMPANY**

**OCTOBER 2021**

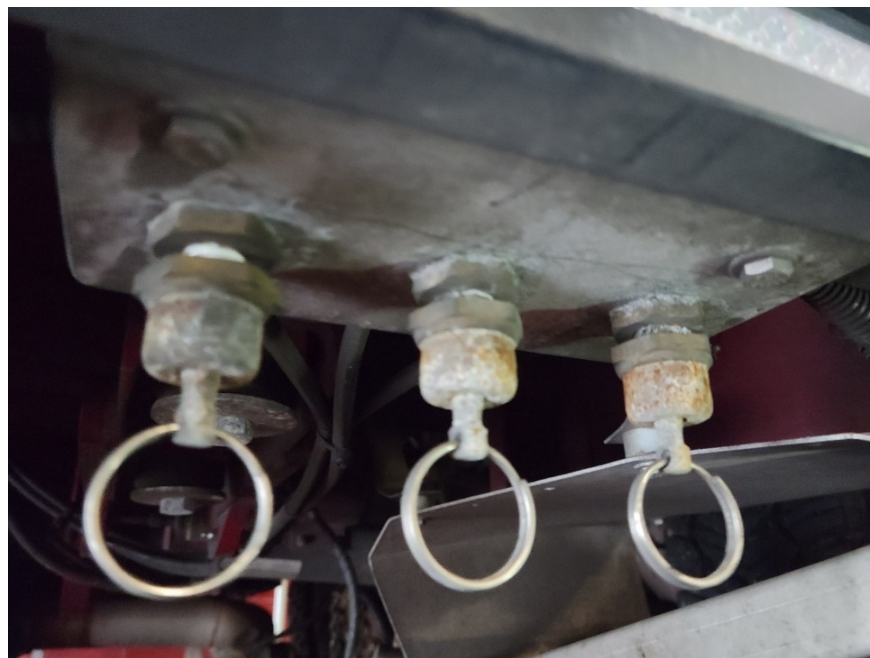
**Underside corrosion needs to be mitigated.**

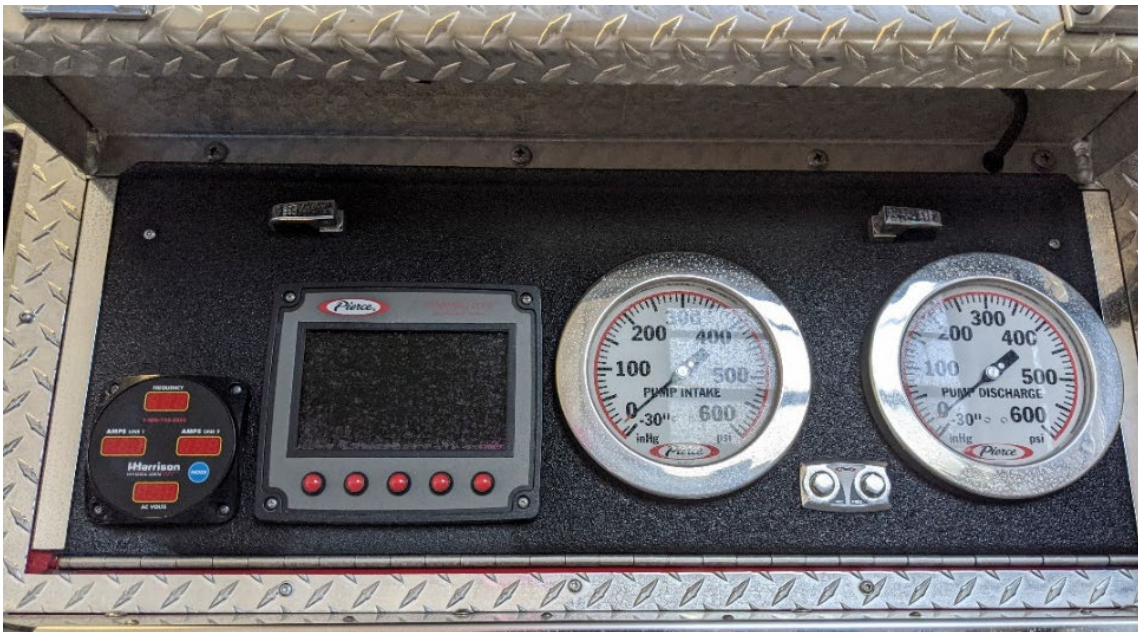
**Water spots making the gauges and computer screen difficult to see.**

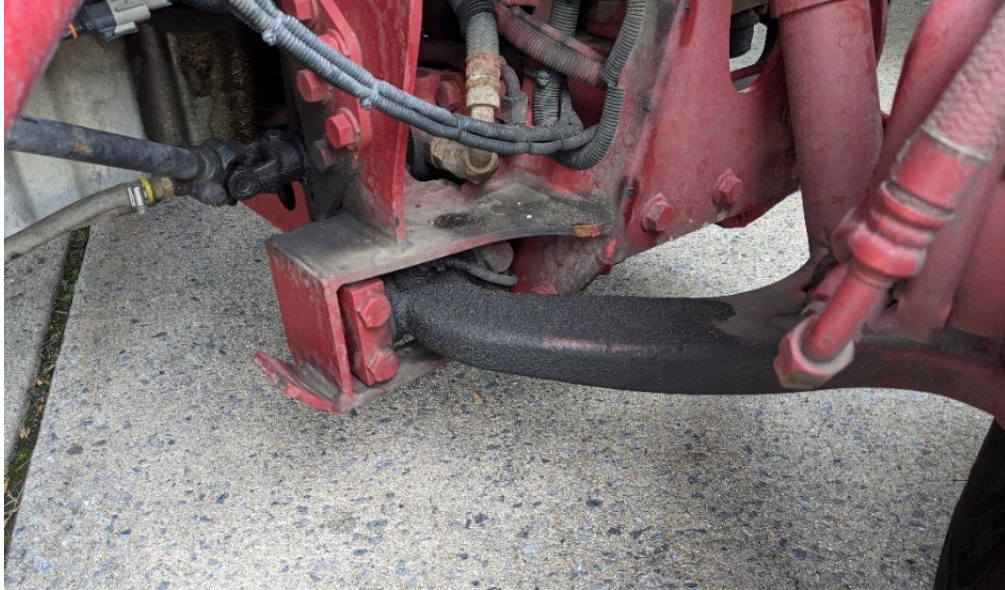
**The apparatus needs a good steam cleaning**

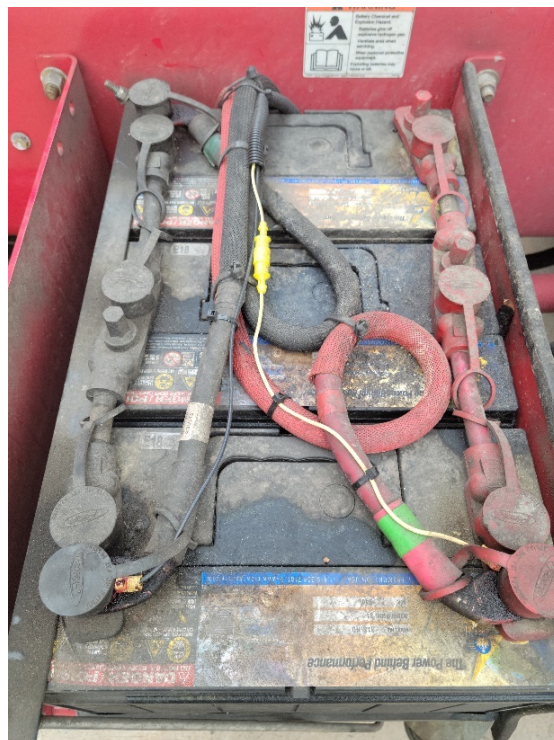
**Battery needs to be cleaned**

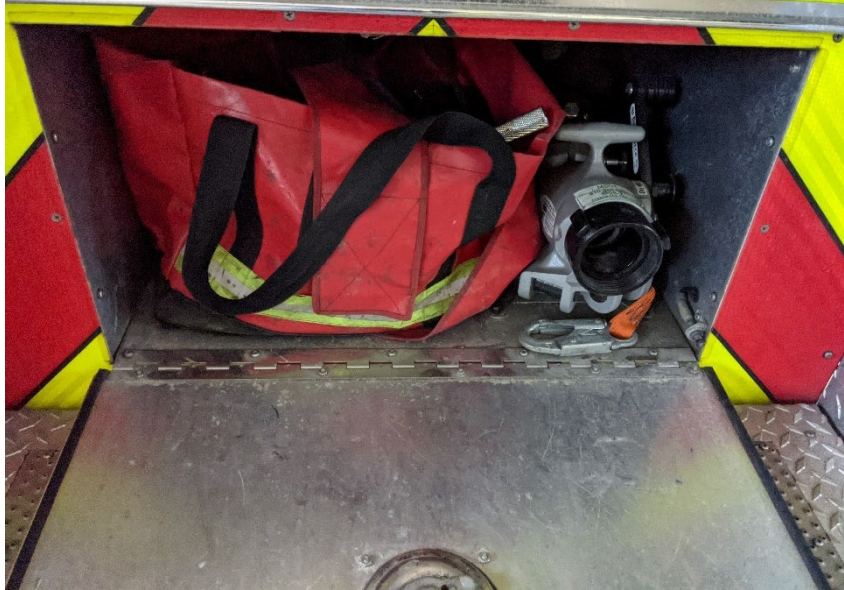
**All equipment should be removed from compartments and both compartments and equipment should be cleaned.**

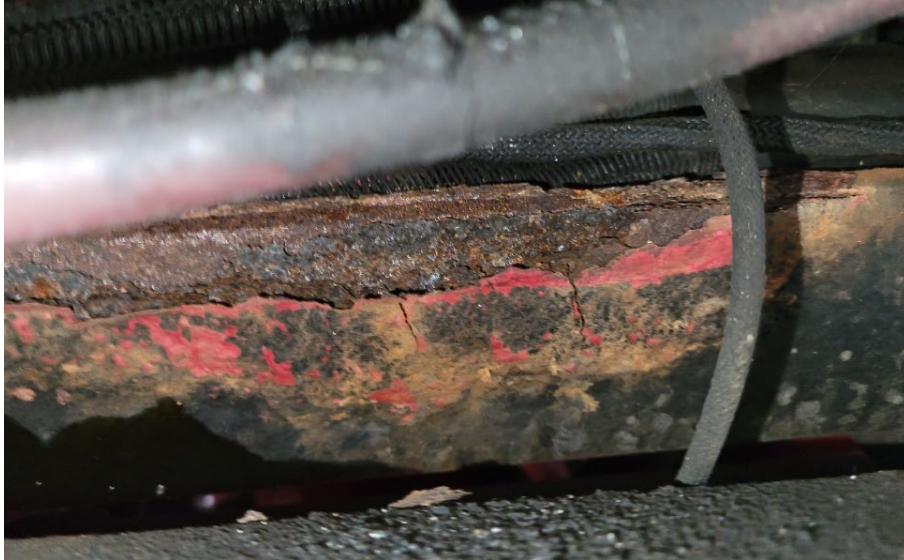
**The frame rails are rusting and delaminating on Engine 251**

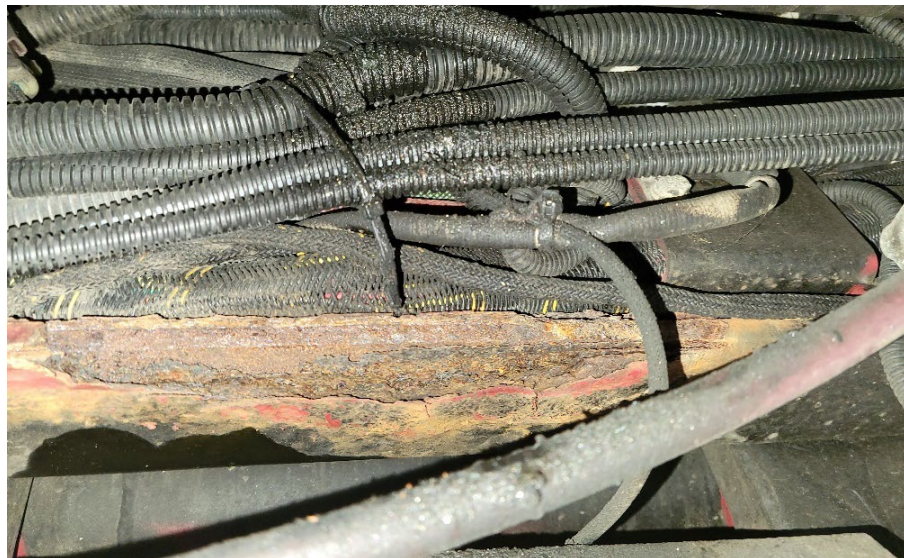
**Frame rail corrosion.**

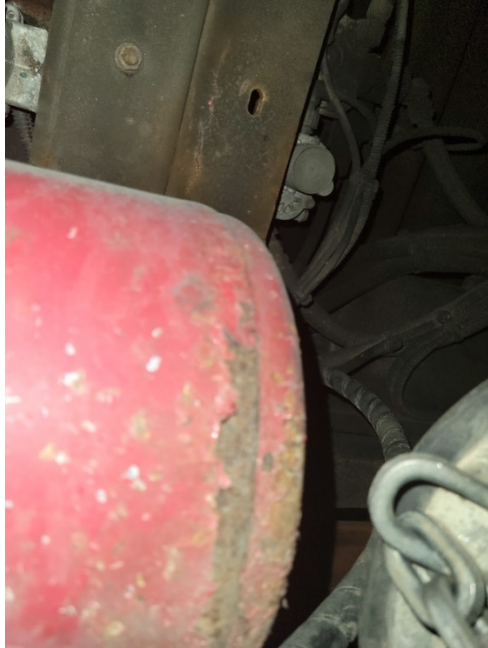
**Air holding tank corrosion**

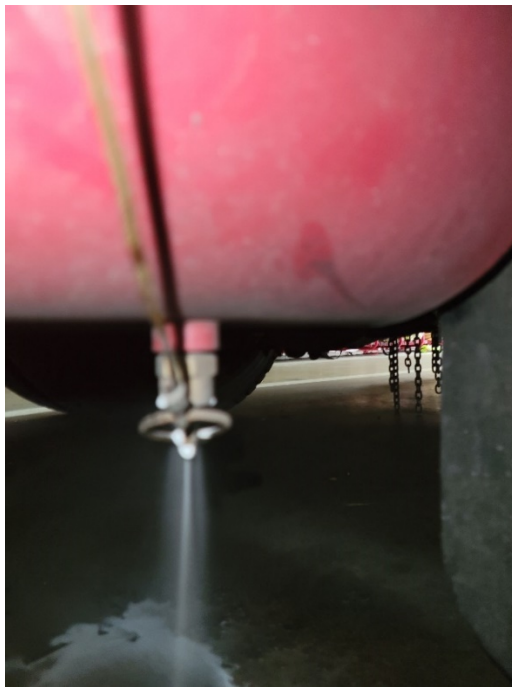
**Excessive moisture in the brake system**

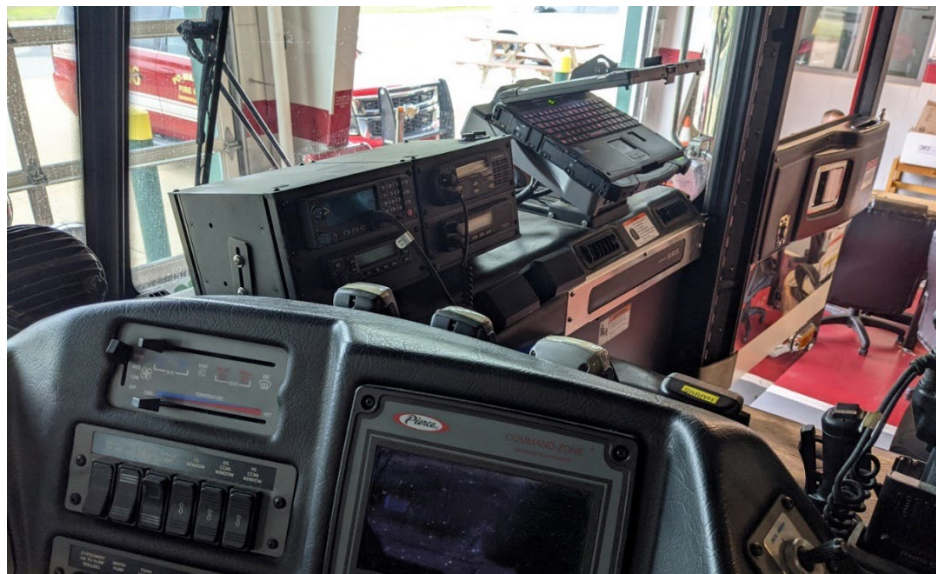
**The MDC and mounted radio equipment block the drivers view while driving.**

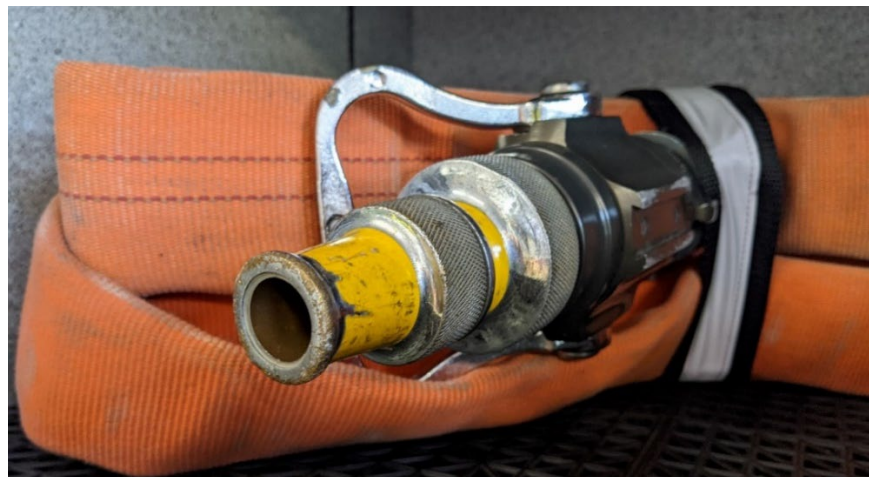
**The standpipe pack has a “overhaul tip” on the nozzle.**

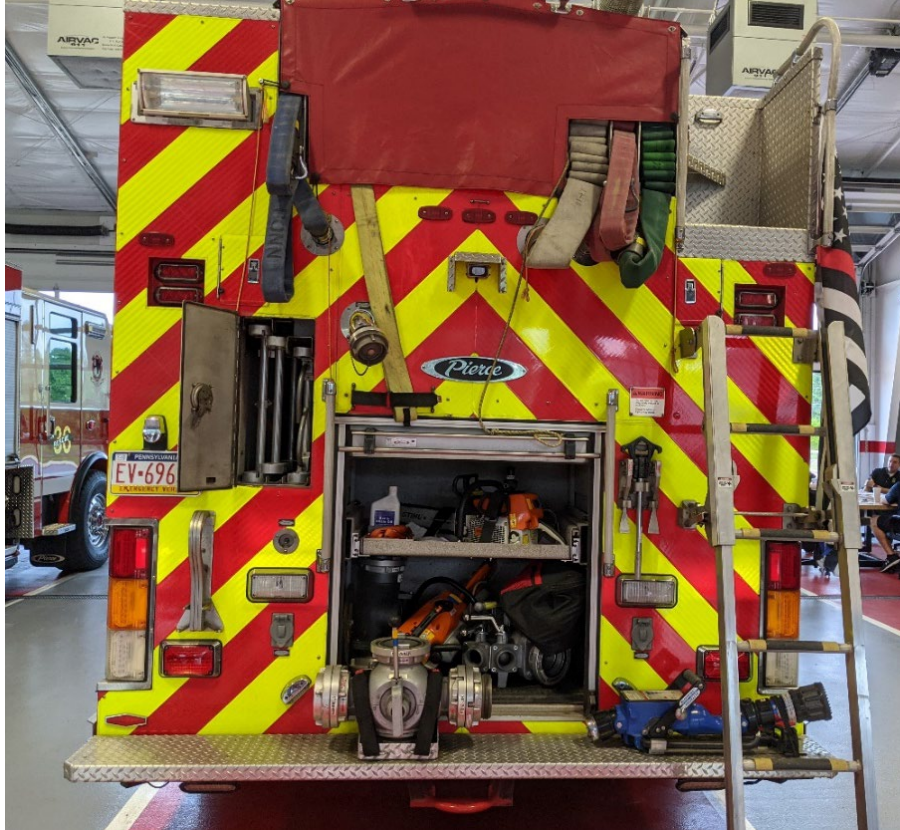
**The hose bed is too high off the ground and the hose bed cover prevents rapid, safe deployment of attack lines.**

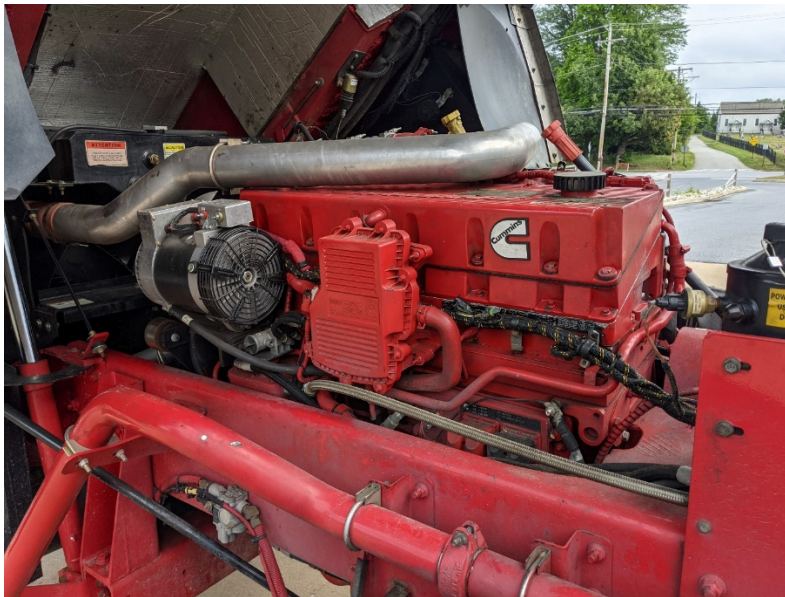
**The engine compartment and frame rails show dirt buildup and needs to be steam cleaned.**

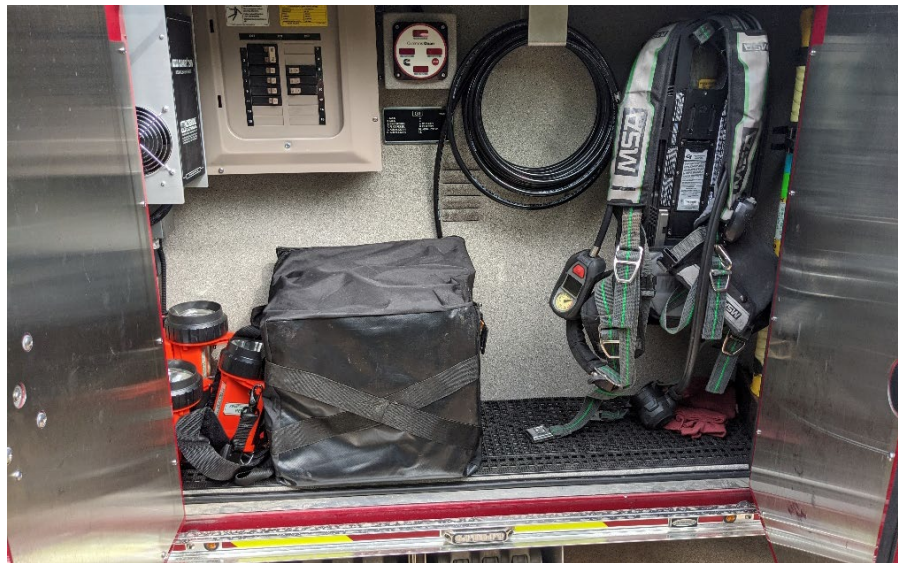
**Portable lights need to be secured in NFPA 9-G rated brackets**

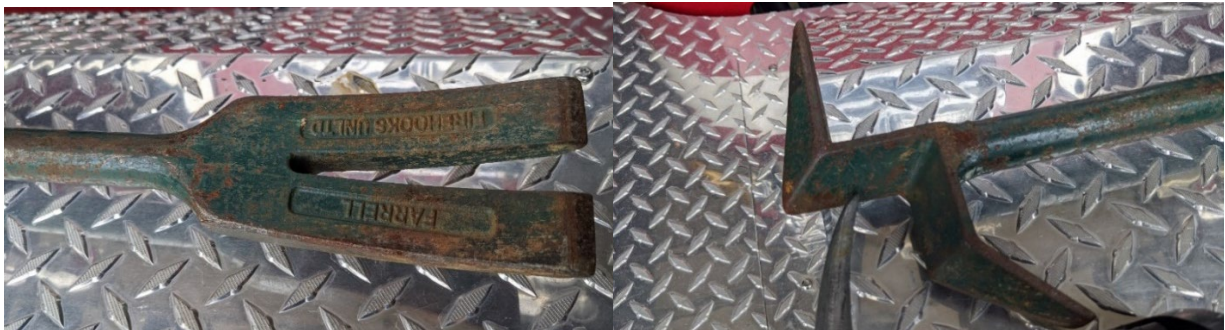
**Tools on the front bumper need to be cleaned of rust and repainted.**

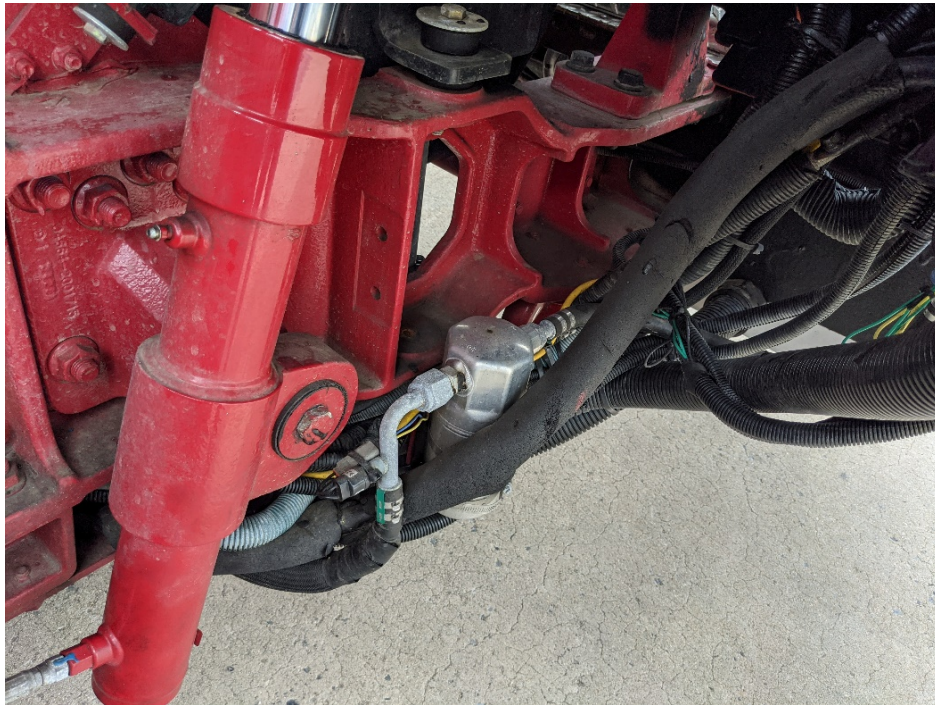
**Repair the chaffing on the hose and the cab.**

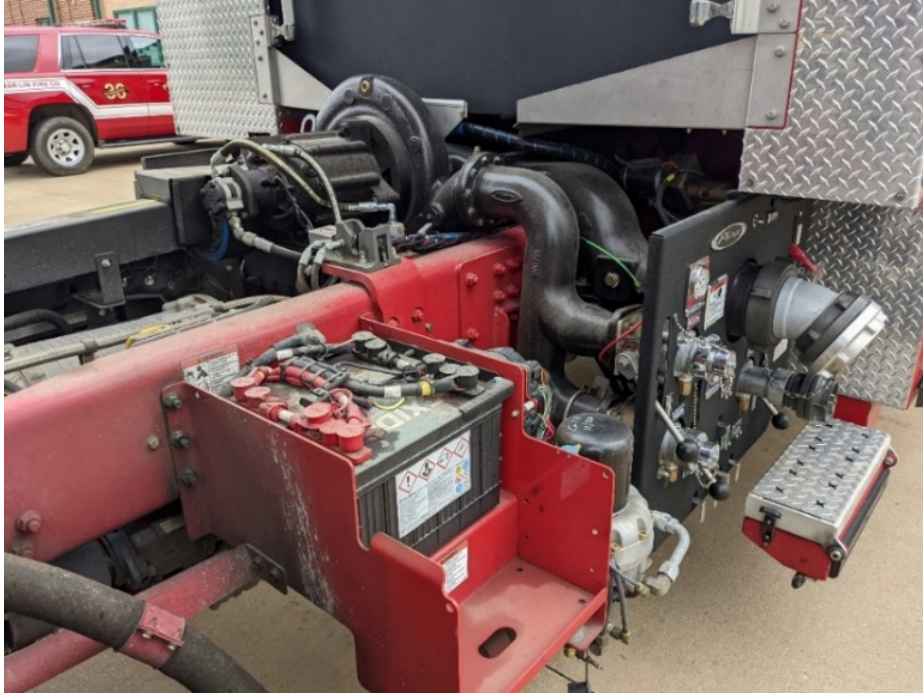
**Frame rails and battery box need to be steam cleaned.**

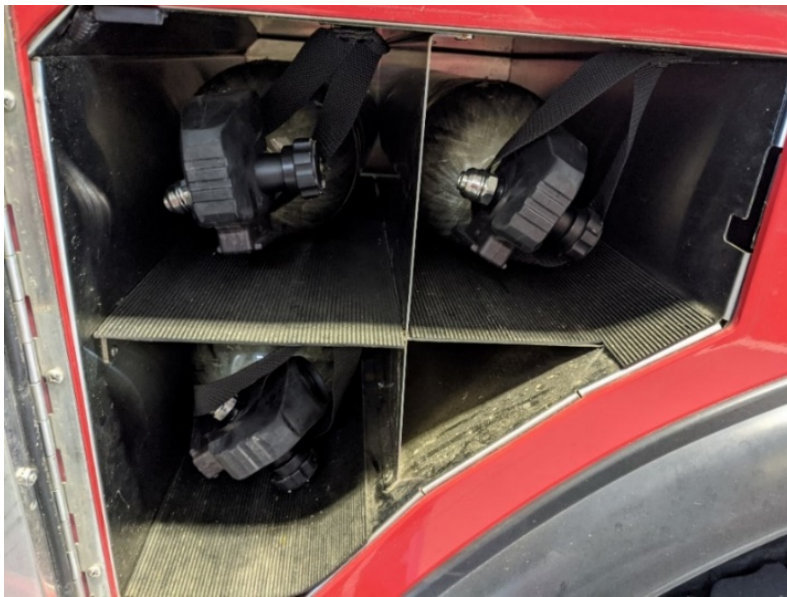
**Wheel well compartment showing signs of dirt intrusion. Compartment needs to be cleaned and gasket inspected and replaced.**

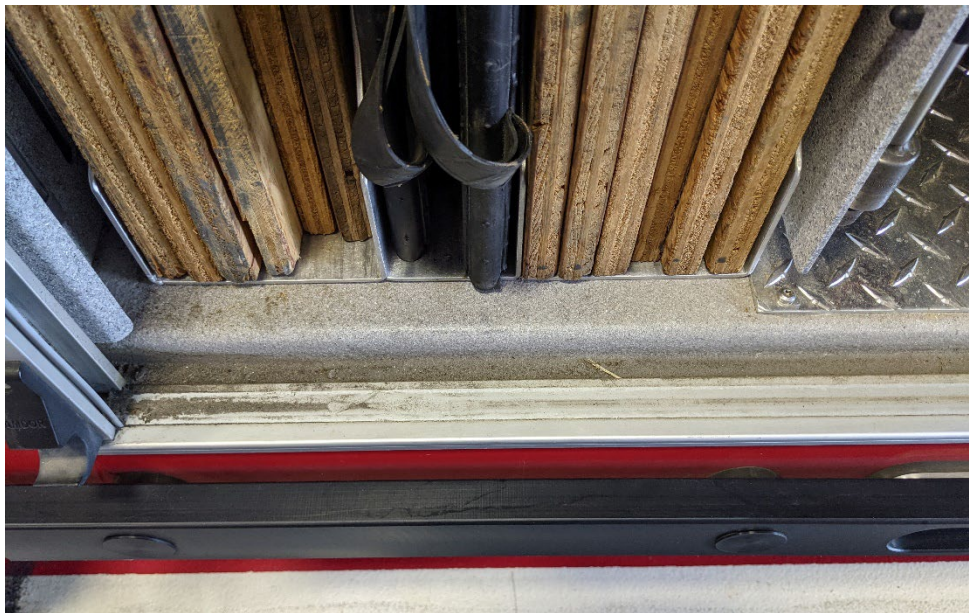
**Dirt intrusion into the airbag compartment.  
Compartments need to be cleaned and rubber gaskets inspected and replaced.**

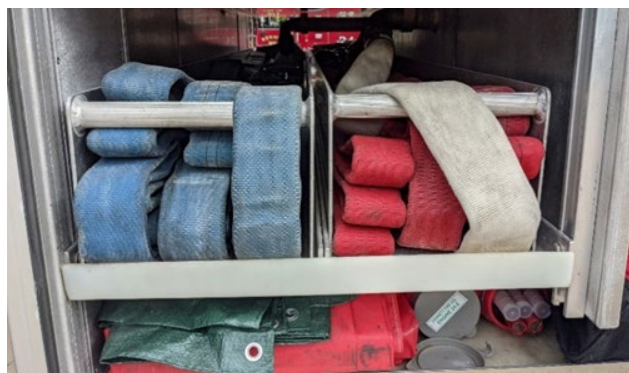
**All hose loads on all engine company apparatus need to be standardized.**

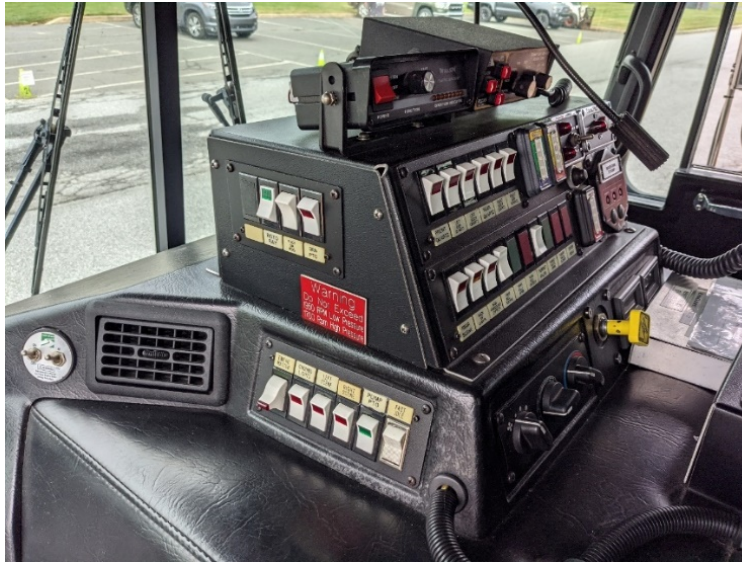
**Poor vision out of the officer's side of the vehicle making it unsafe to drive.**

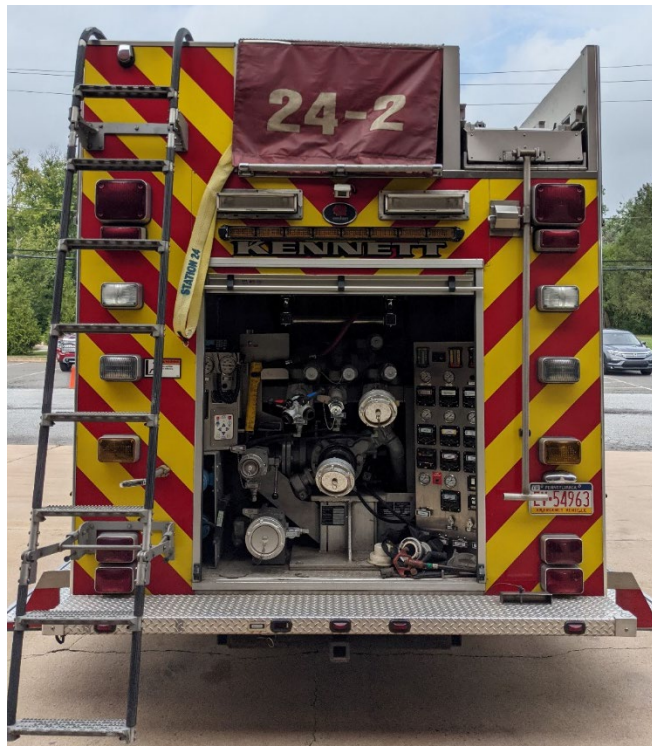
**Hose bed too high off the ground making this unit unsafe to work on.**

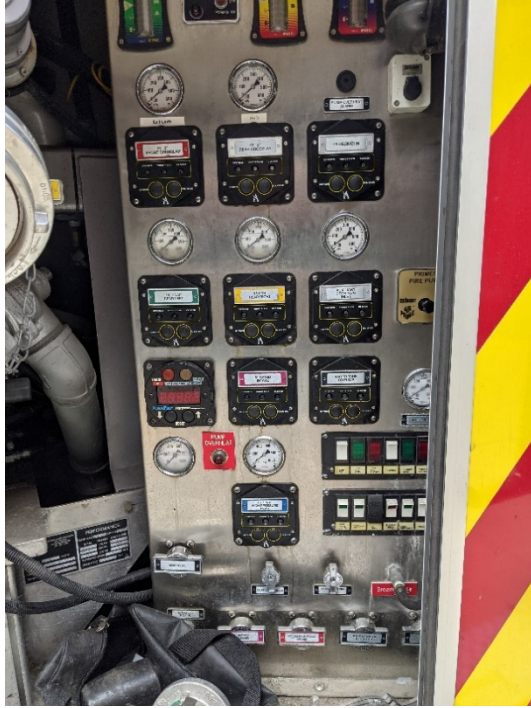
**Electronic pump panel was costly and not needed.**

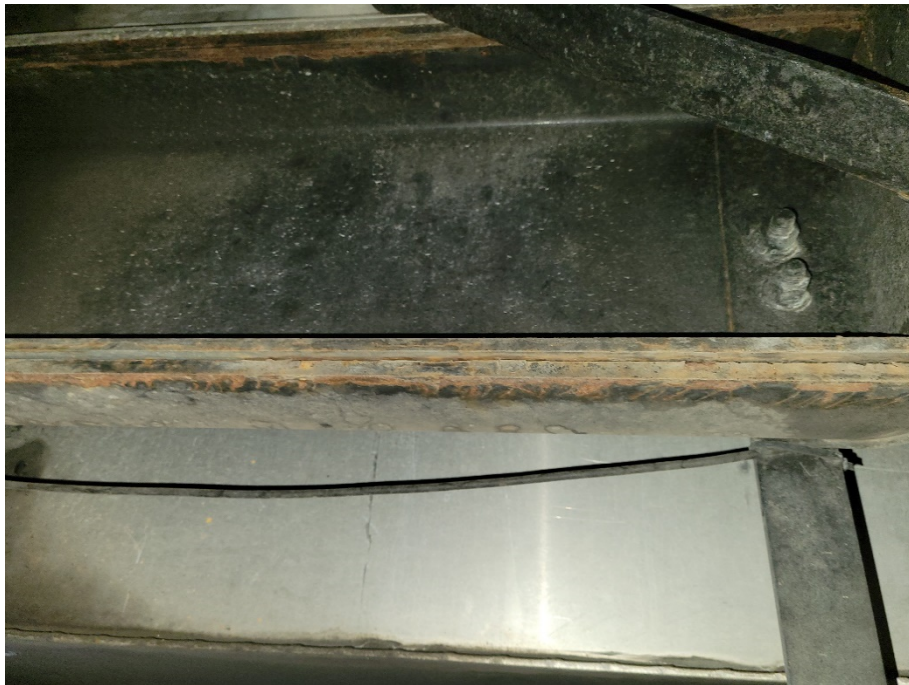
**Rust, corrosion, and dirt accumulating on the frame rails.**

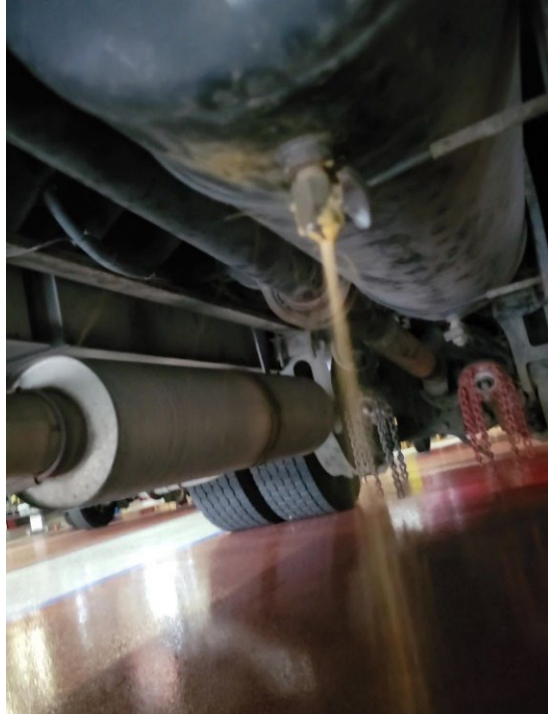
**Excessive moisture out of the air brake system holding tank.**

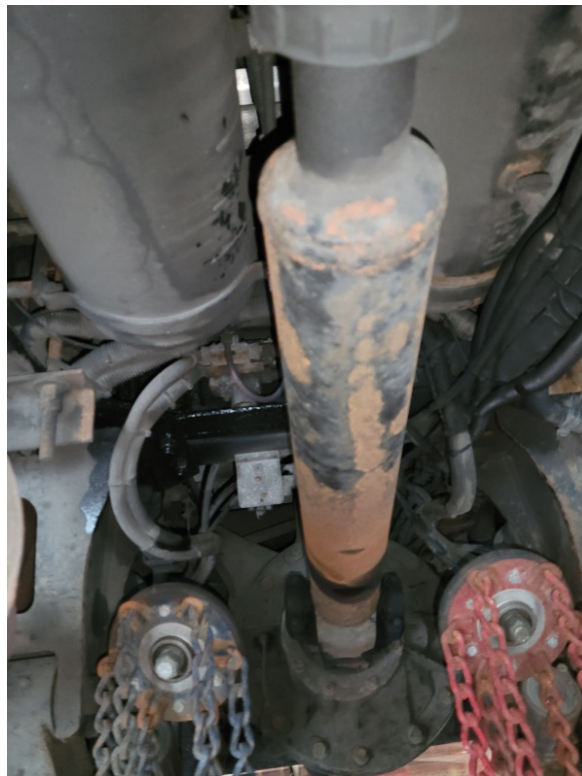
**Corrosion on the pump drive shaft.**

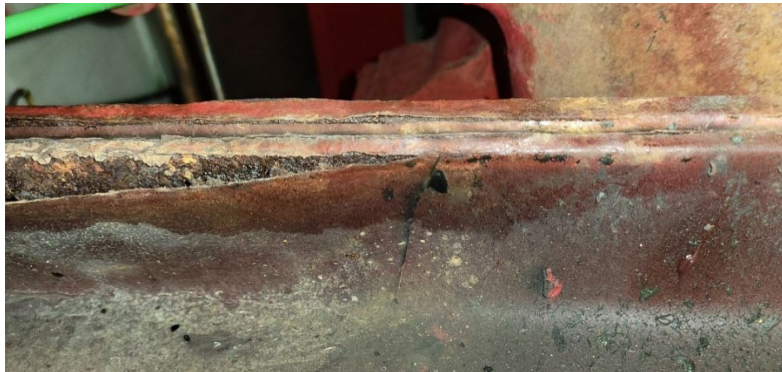
This unit is showing its age on the underside with moderate corrosion on the frame rails and throughout the chassis. The stainless-steel body is in good condition, due to its construction. Although this unit would normally require corrosion remediation, it is not recommended due to the vehicles age and anticipated replacement in 2023. No major repairs or expenditures should be made on this vehicle, and it should be cycled out of the fleet. Tanker 36 responded to 44 calls and the fire company spent \$4,377 in 2020. The current Tanker 36 would be disposed of and sold once the new Engine / Tanker 24 enters service in 2023.

**The underside shows moderate to severe corrosion and would need to be repaired if the vehicle is not removed from the fleet.**

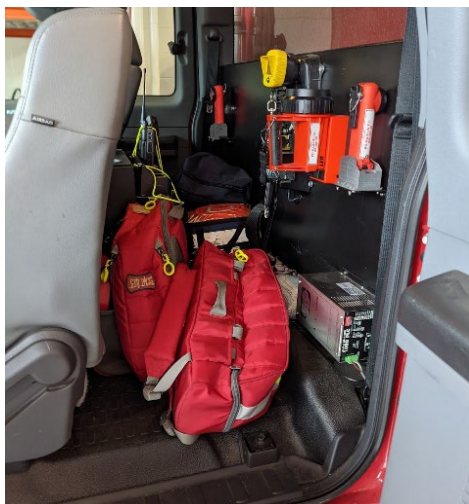
**Loose equipment in the cab of Brush 36 needs to be secured in NFPA 9-G brackets**

- In addition to the supply hose, some of the equipment being carried should be modified to support water supply operations. Equipment such as an LDH manifold, Siamese fittings, etc.
- Secure all loose equipment that is present in the cab with a NFPA compliant 9G rated non-marring brackets.

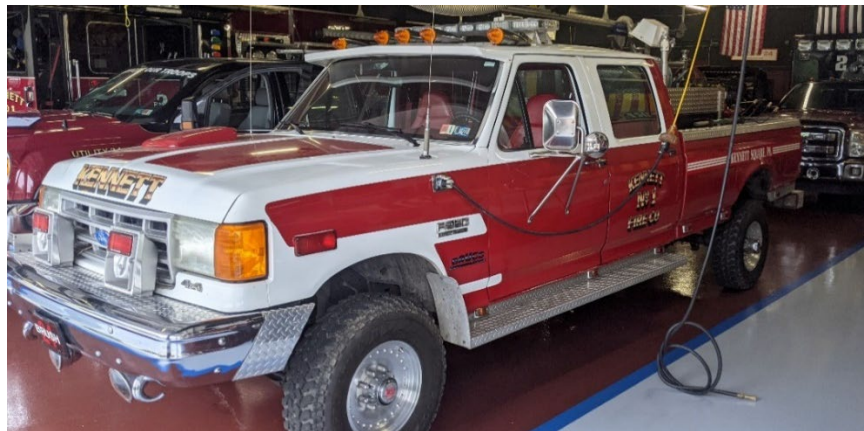
**Kennett Brush 24**

Remove Kennett's Brush truck from the fleet. The age alone makes this vehicle obsolete and does not adhere to the current NFPA 1901 standards. This unit averaged 3 calls a year for the last 3 years. This lack of activity does not support a replacement vehicle.

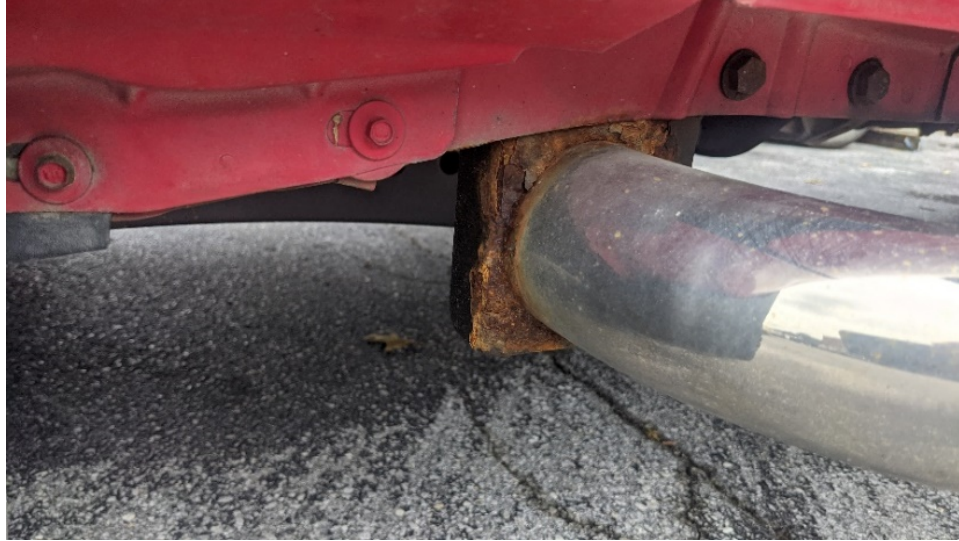
- Utility 25 has moderate corrosion on the underside of the chassis and on the passengers and drivers step brackets. The underside should be thoroughly steamed cleaned, and the rust remediated.

**Rust remediation needed on Utility 25 pictured drivers step bracket.**

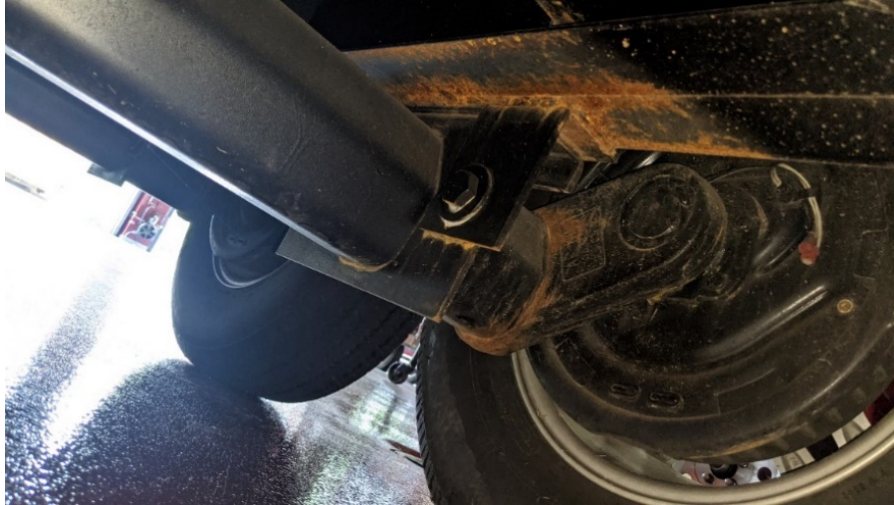
**Kennett's enclosed trailer needs four new tires and rust remediation.**

- The following support trailers need new tires due to their age: Po-Mar-Lin Large Animal Rescue Trailer, Longwood enclosed Water Rescue trailer, Kennett boat trailer, Kennett Water Rescue Trailer.
- Support trailers should be replaced on an as needed basis. When trailers are replaced, consideration should be given to the size and weight of the trailer. Specifying trailers that are too large and heavy limit the vehicles in the fleet that can tow them. See above recommendation about a Water Rescue vehicle.
- The underside of Kennett's enclosed Water Rescue Trailer shall be steam cleaned and have any rust remediated. This will help ensure the trailers longevity as part of the fleet.
