**KENNETT FIRE & EMS REGIONAL  
COMMISSION**

**FIRE APPARATUS FLEET REVIEW AND  
ASSESSMENT**

**KENNETT FIRE COMPANY  
LONGWOOD FIRE COMPANY  
PO-MAR-LIN FIRE COMPANY**

**OCTOBER 2021**

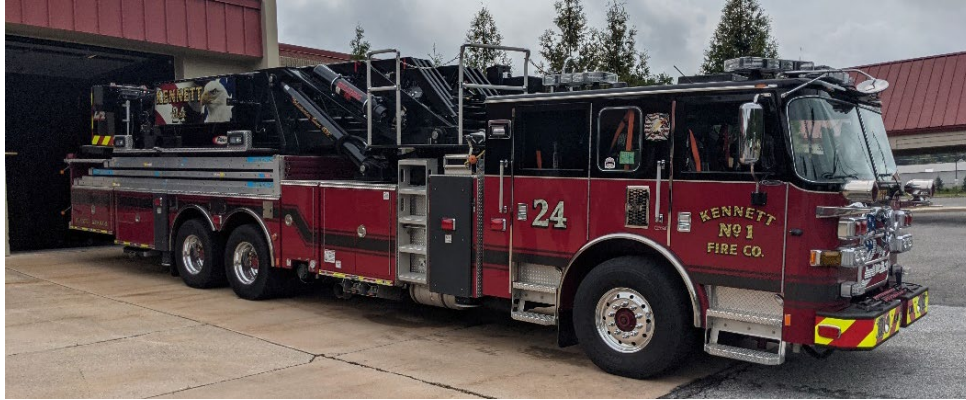
**Tower 24 is a well-designed and equipped unit with excellent ground ladder compliment**

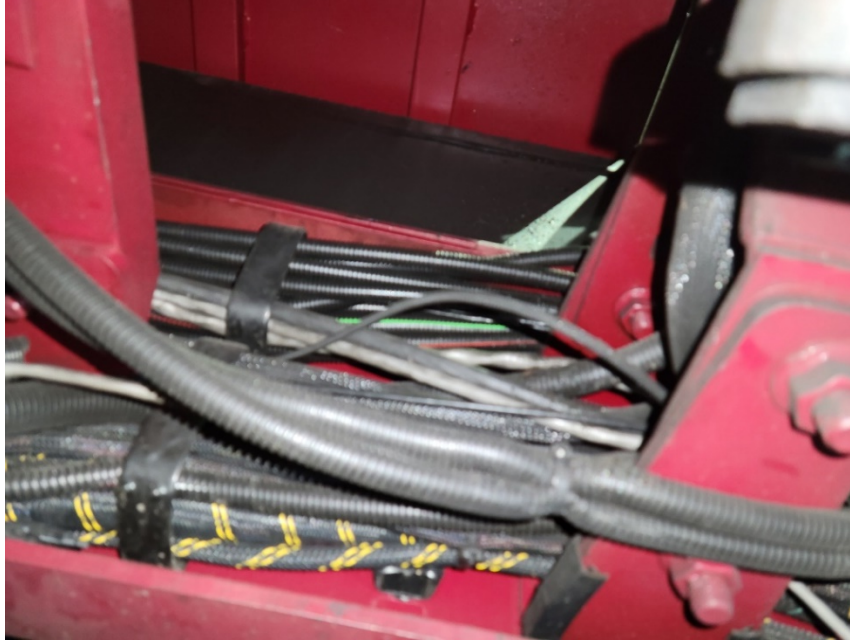
**Painting underside components helps protect them from corrosion**

1. The chassis frame rails; and body substructure components should be thoroughly steam cleaned with all exposed rust and corrosion removed. The chassis steam cleaning should be conducted on at least an annual basis to remove accumulated dirt, road debris and surface rust from the chassis and other components. These areas once cleaned of all rust should be treated with a weather resistant undercoating like Krown (<https://www.krown.com/en/>) or Carwell (<http://www.carwell.com/>).

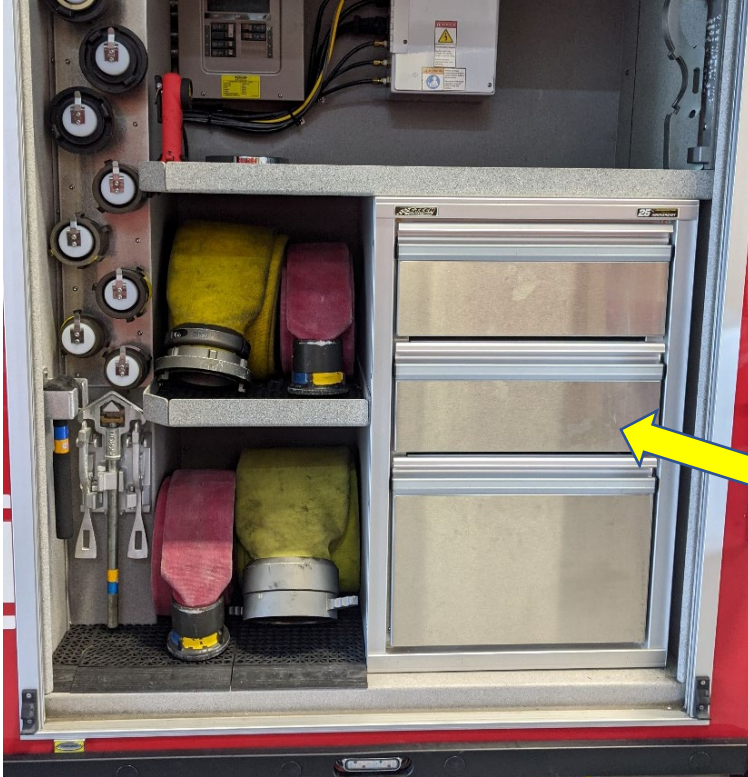
**Compartment with costly toolbox.**

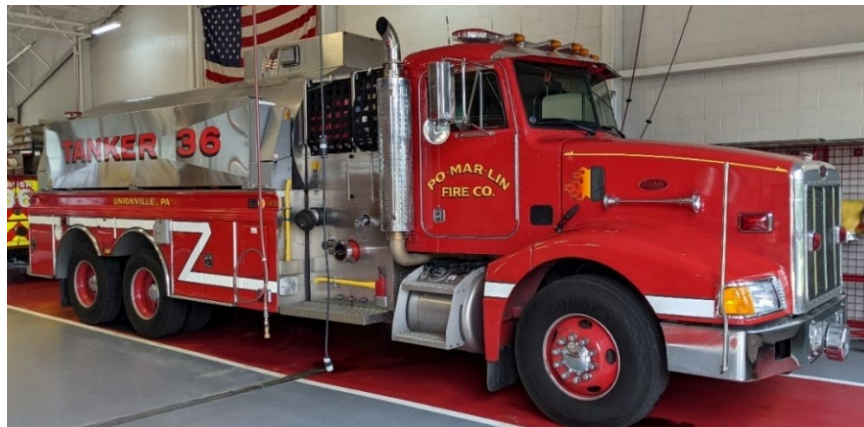
This unit is showing its age on the underside with moderate corrosion on the frame rails and throughout the chassis. The stainless-steel body is in good condition, due to its construction. Although this unit would normally require corrosion remediation, it is not recommended due to the vehicles age and anticipated replacement in 2023. No major repairs or expenditures should be made on this vehicle, and it should be cycled out of the fleet. Tanker 36 responded to 44 calls and the fire company spent \$4,377 in 2020. The current Tanker 36 would be disposed of and sold once the new Engine / Tanker 24 enters service in 2023.

**Tanker 36 is well equipped for the mission.**

- This unit should be removed from the fleet and replaced with a pumper-tanker type vehicle in 2023 when the unit would be 20 years old. NFPA 1911 recommends that vehicles be cycled out of the fleet or placed into reserve status when they reach 20 years of life. Due to the corrosion, this vehicle should be removed from the fleet.

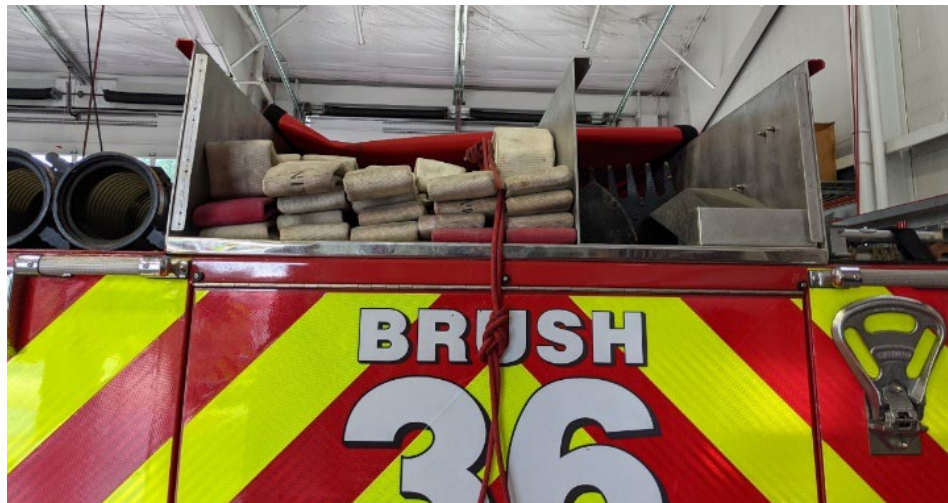
**Rear hose bed of Brush 36**

- It is recommended that Brush 36 be utilized as a water supply unit in addition to operating as a brush unit. This will complement the fleet and greatly assist in the water supply hurdles throughout the response area. To be an effective water supply unit Brush 36 should carry a minimum of 800 feet of 5-inch supply hose and 300 to 400 feet of 3-inch hose.
