# Department Head Report – Public Works

Prepared By: Theodore D. Otteni, PE – Director of Public Works

Date Prepared: January 20, 2026

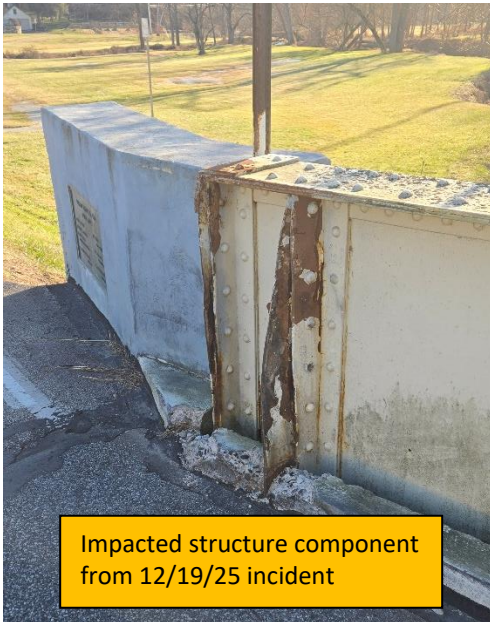
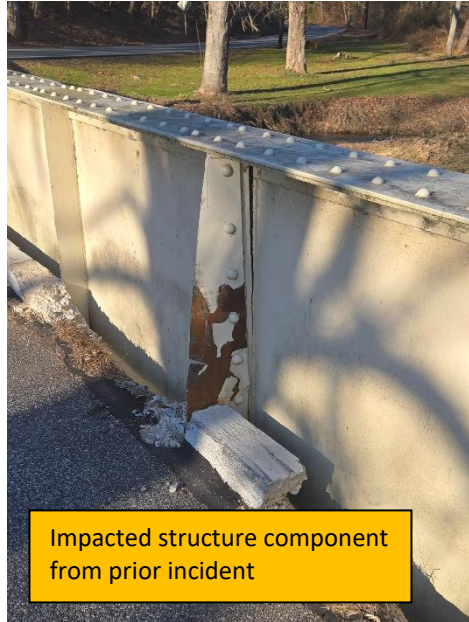
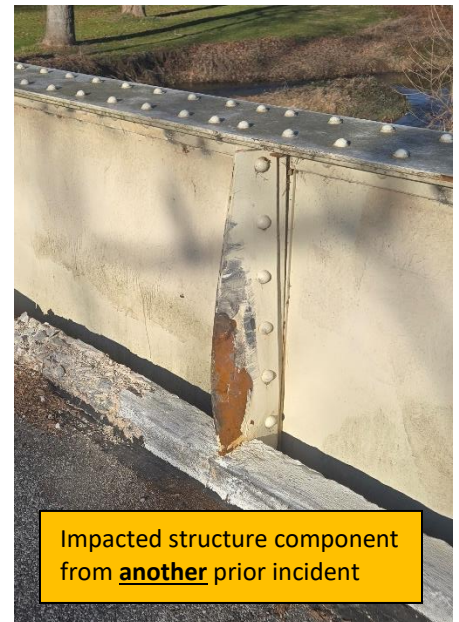
Following a vehicular crash involving the bridge on W. Hillendale Road, the Public Works Department worked with Chester County Bridge Unit (owners of the bridge) to verify the structure was still safe for use. This was not the first crash on the bridge.

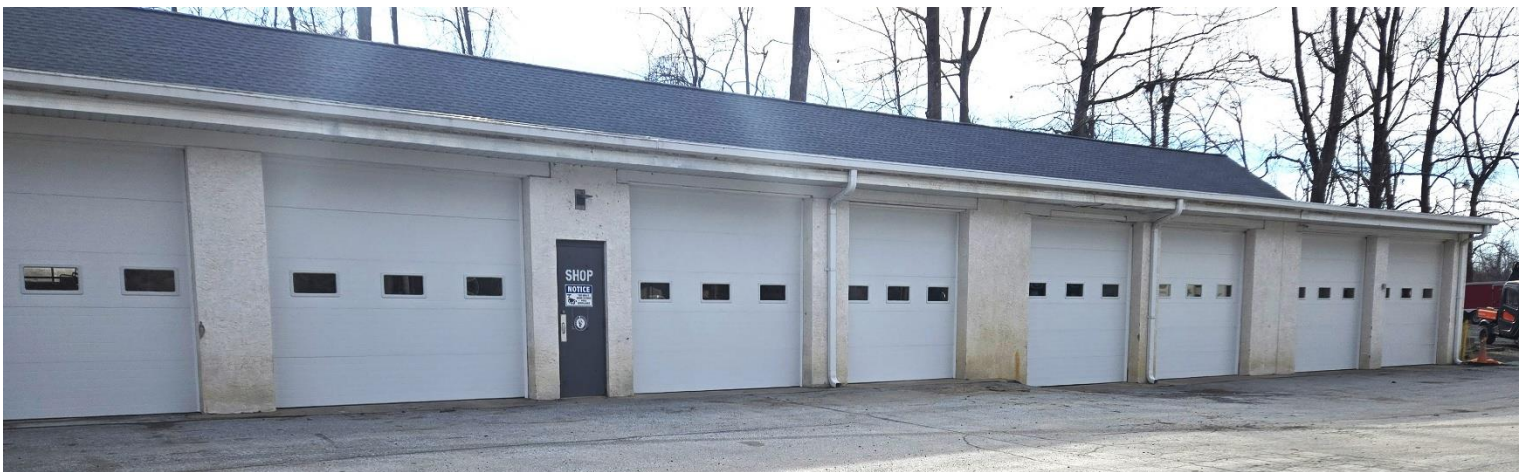
Eight new garage doors were installed at the Public Works facility. The prior doors were more than 30 years old and were in dilapidated condition. The new doors are insulated and have new weather stripping to improve heating efficiency. The doors also have mechanical openers, therefore the drivers no longer need to get into and out of the trucks when returning from a long plow route (*this is a documented common worker injury situation*).

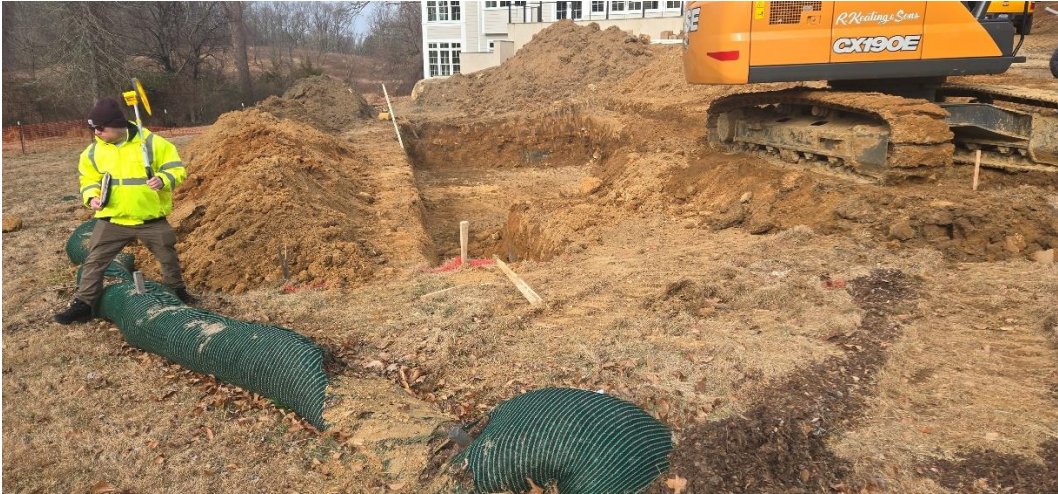
Inspection of a stormwater basin at a residential lot. Initial inspection to verify size and depth of BMP prior to filling and backfill.

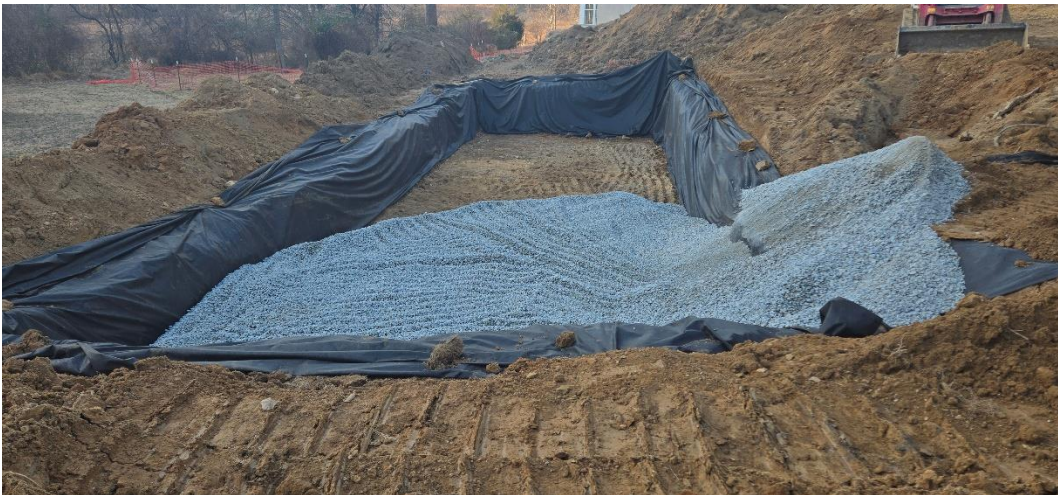
Follow-up inspection of a stormwater basin to observe the geofabric and placement of the clean stone fill.

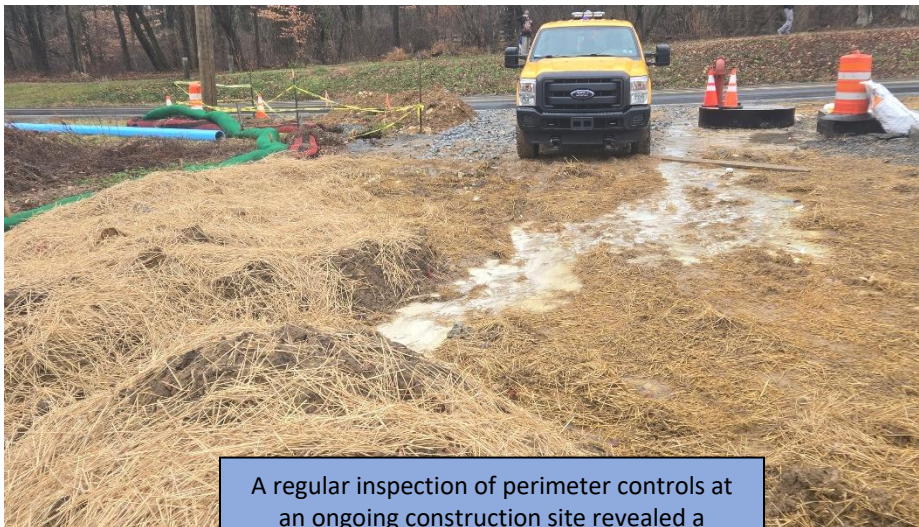
A regular inspection of perimeter controls at an ongoing construction site revealed a suspicious powder mixing with runoff.

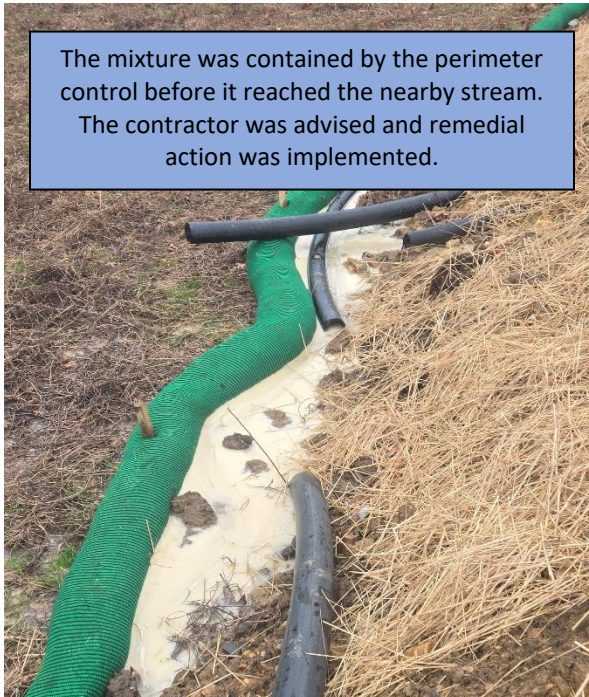
The mixture was contained by the perimeter control before it reached the nearby stream. The contractor was advised and remedial action was implemented.
